**Flood Control Project Maintenance
Levee Inspections**

Fall 2018 Levee Maintenance Deficiency Summary Report

**Flood Control Project Maintenance
Levee Inspections****LMA District Cover Sheet****Fall 2018 Levee Inspection Results****Solano County Public Works Mellin Levee**

Solano County Public Works Mellin Levee

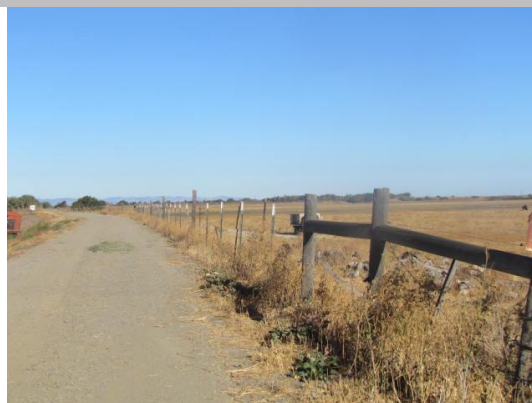
Photo 1 of 1 : FA_2018_NA0012_258_3_20180925_00002.jpg

LM Start	0.01	Rating **	M	Issue No.	3
LM End	0.59	Issue Type +	En	Location *	WS
Category	Earthen Levee			GPS Latitude/Longitude	
				Start	End
Item	Encroachments			38.174167°	38.180084°
				-121.674312°	-121.681992°
DWR ID	DWR_NA0012_01_s_2012_3				
Comment Code					
FE : Fence					
Inspector Comment

Looking west at fence on waterside shoulder.

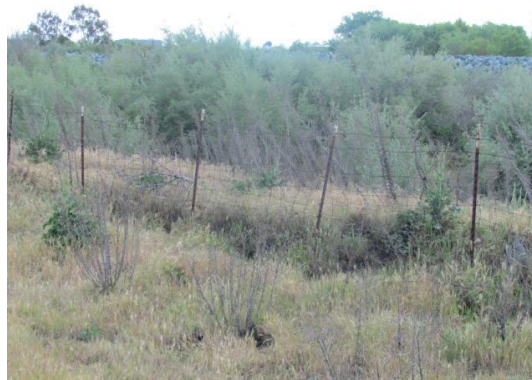
Photo 1 of 1 : FA_2018_NA0012_258_4_20180925_00003.jpg

LM Start	0.10	Rating **	M	Issue No.	4
LM End	0.28	Issue Type +	En	Location *	LS
Category	Earthen Levee			GPS Latitude/Longitude	
				Start	End
Item	Encroachments			38.175115 °	38.176805 °
				-121.675463 °	-121.677893 °
DWR ID	DWR_NA0012_01_s_2012_4				
Comment Code					
FE : Fence					
Inspector Comment

Looking southeast at fence on landward slope.

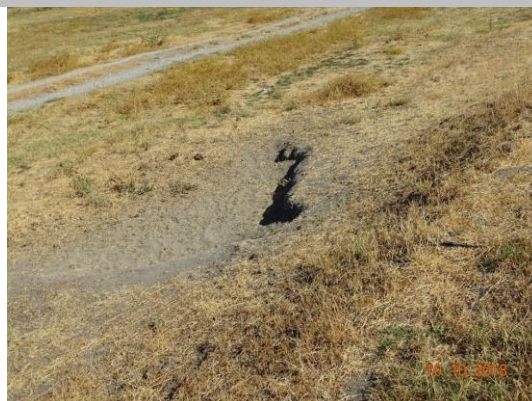
Photo 1 of 1 : FA_2018_NA0012_258_11_20181011_00007.jpg

LM Start	0.12	Rating **	M	Issue No.	11
LM End	0.12	Issue Type +	Ma	Location *	WS
Category	Earthen Levee			GPS Latitude/Longitude	
				Start	End
Item	Erosion / Bank Caving			38.175333 °	38.175333 °
				-121.675780 °	-121.675780 °
DWR ID	DWR_NA0012_01_f_2018_11				
Comment Code					
E1 : Note and monitor erosion site.					
Inspector Comment					
Erosion at land side toe.

View of erosion into water side toe (October 2018).

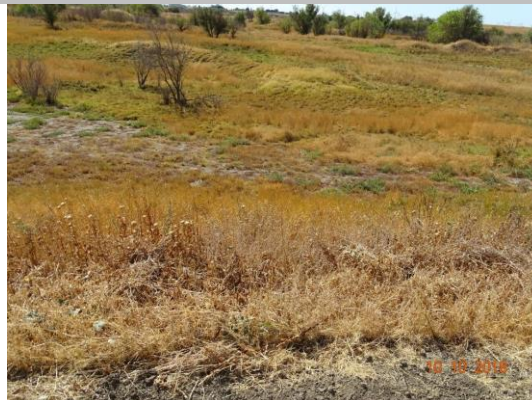
Photo 1 of 1 : FA_2018_NA0012_258_1_20181011_00005.jpg

LM Start	0.50	Rating **	M	Issue No.	1
LM End	0.55	Issue Type +	Ma	Location *	LS
Category	Earthen Levee			GPS Latitude/Longitude	
				Start	End
Item	Vegetation			38.179138 °	38.179638 °
				-121.680727 °	-121.681370 °
DWR ID	DWR_NA0012_01_f_2018_1				
Comment Code					
V1 : Control annual grass and weeds on the levee slopes and easements.					
Inspector Comment					
Remove vegetation to bottom of land side slope.

View of vegetation on land side slope that should be removed (October 2018).
